1. Report No. USCG 16732/0002HQS88	2. Government Accession No.	3. Recipient's Catalog No.	
4. Title and Subtitle Marine Casualty Report, SS OMI YUKON, O.N. 547919, Explosion and fire on 28 October 1986 in the Pacific Ocean with multiple deaths and injuries		5. Report Date

SS OMI YUKON, O.N. 547919; EXPLOSIONS AND FIRE
ON 28 OCTOBER 1986 IN THE PACIFIC OCEAN APPROXIMATELY
1000 MILES WEST OF HONOLULU, HI, WITH MULTIPLE
LOSS OF LIFE AND PERSONNEL INJURIES

Commandant's Action

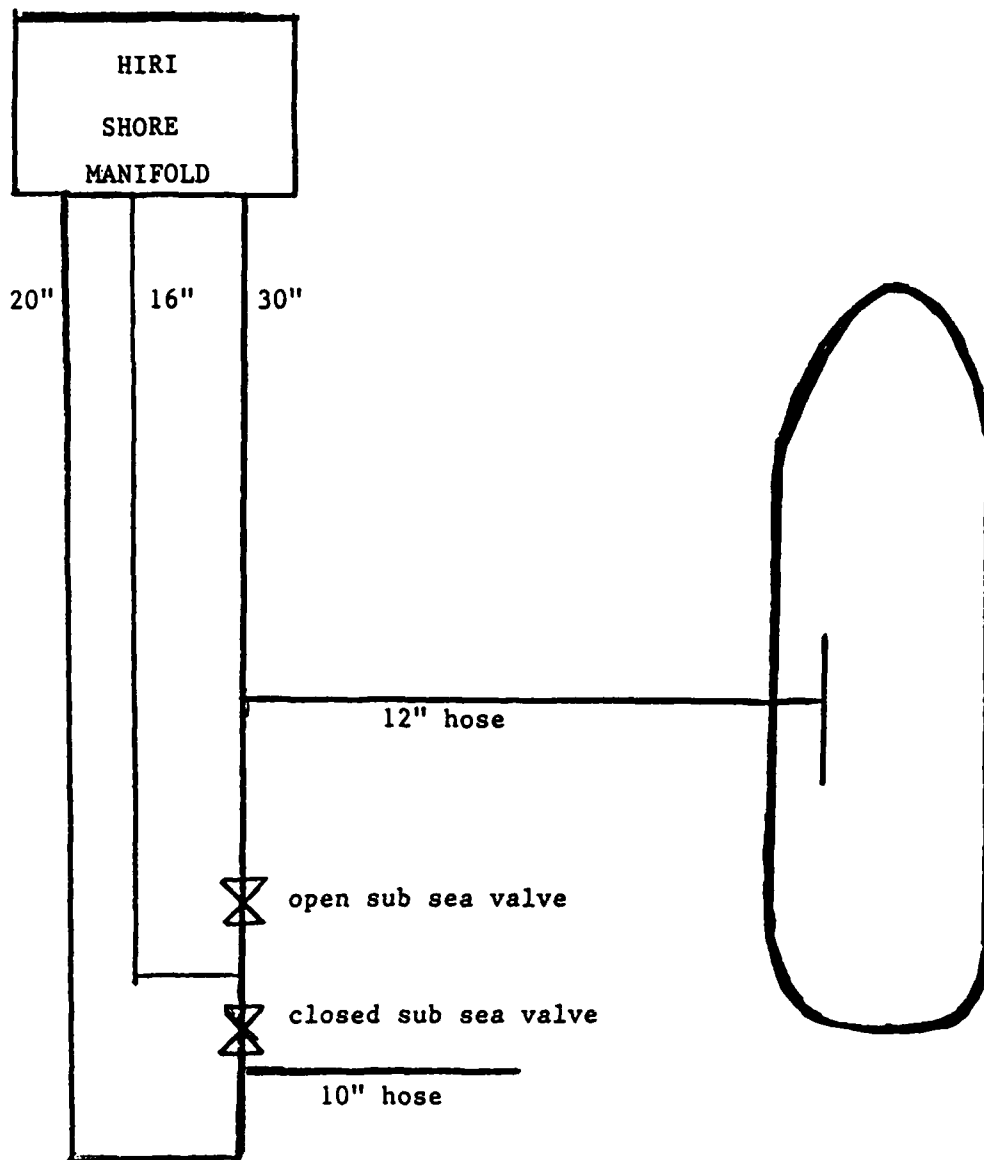
23. In preparation for bunkering the OMI YUKON using the sub-sea pipeline, HIRI personnel pumped flush oil into the 16 inch sub-sea line and recirculated it back through the 30 inch sub-sea line to clear a prior load of crude oil. Flush oil starts out as diesel grade distillate, but as it is used to push other products through the refinery it becomes contaminated with the other products it comes in contact with; such as crude oils, gasolines and other distillate products. Eventually, contaminated flush oil is pumped into a crude oil tank and processed through the refinery again.

24. At 1350 on 23 October 1986, the 30 inch line was reported to be filled with 10,325 bbls of bunkers from tank 307 (the tank used to blend the ordered bunkers for the vessel) and behind that in the 30 inch line was flush oil to push the bunkers out to the vessel. The 30 inch line holds approximately 12,500 bbls. The vessel only ordered 7,950 bbls but additional bunkers were put in the line to insure that the expected mixing of the flush oil with the bunkers at the interface was pushed well beyond the sub-sea hose connection. Refinery personnel determined the locations of the interface between products based on tank gaugings. The refinery pumps the leading interface between the flush oil and fuel oil past the location of the hose connection at the sub-sea manifold recirculating it back to the refinery through the 16 inch line.

Redrawn from Exhibit #41 originally prepared by Captain Kuntz
